New Brighton Pier Earthquake Repairs

Safety in Design Considerations

Mark Humphery
Senior Structural Engineer
CCC Facilities & Structures Team

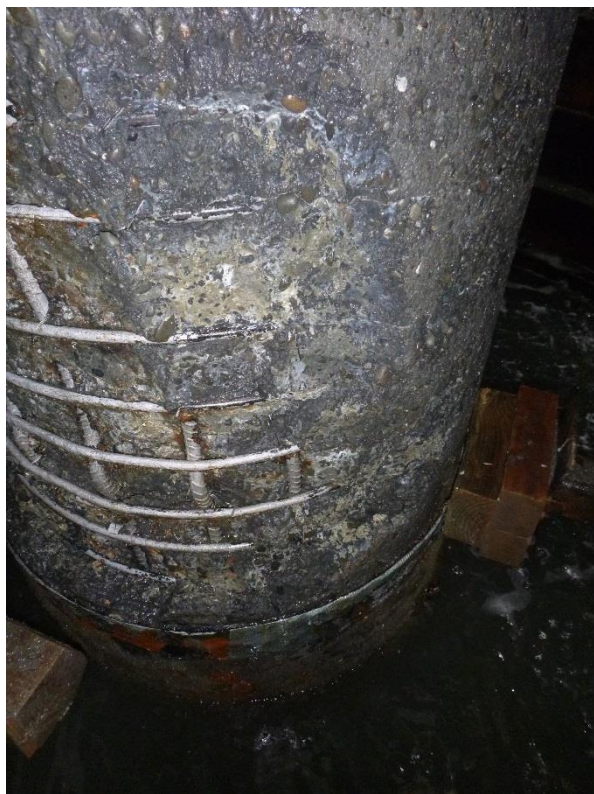
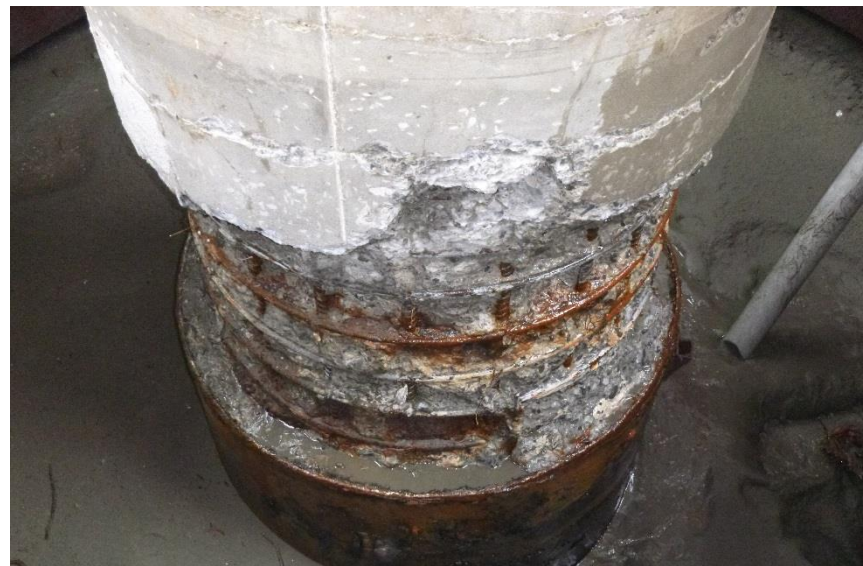
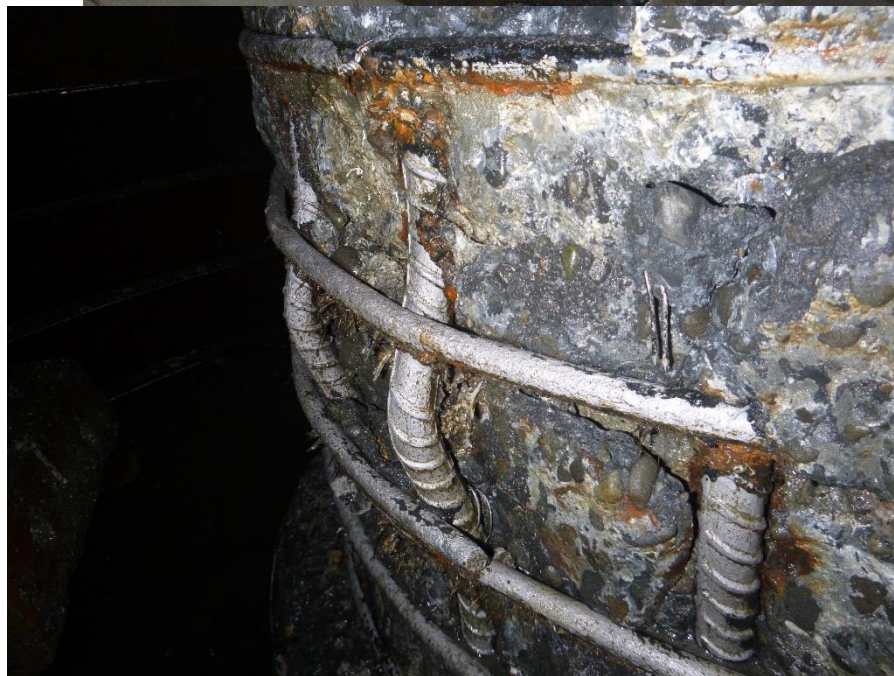
EQ Damage

- Loss of Seismic Strength
- Corrosion of reinforcement
- Settlement of column #4

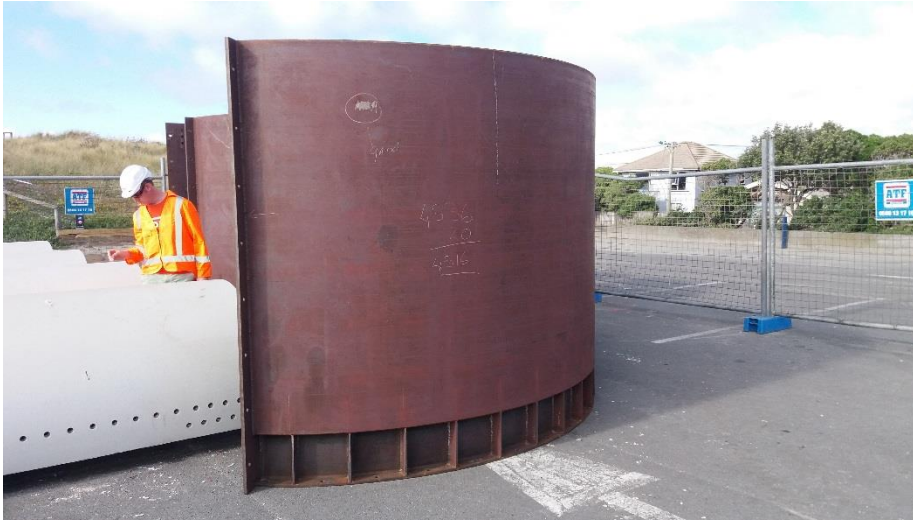
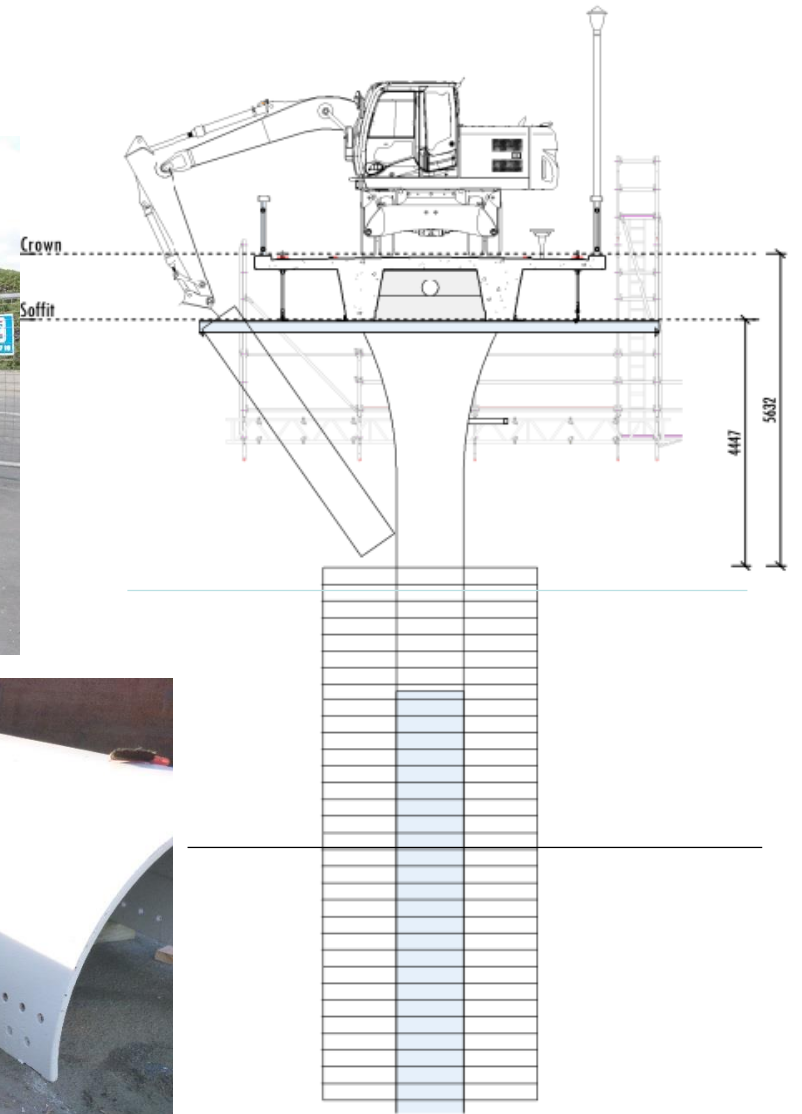
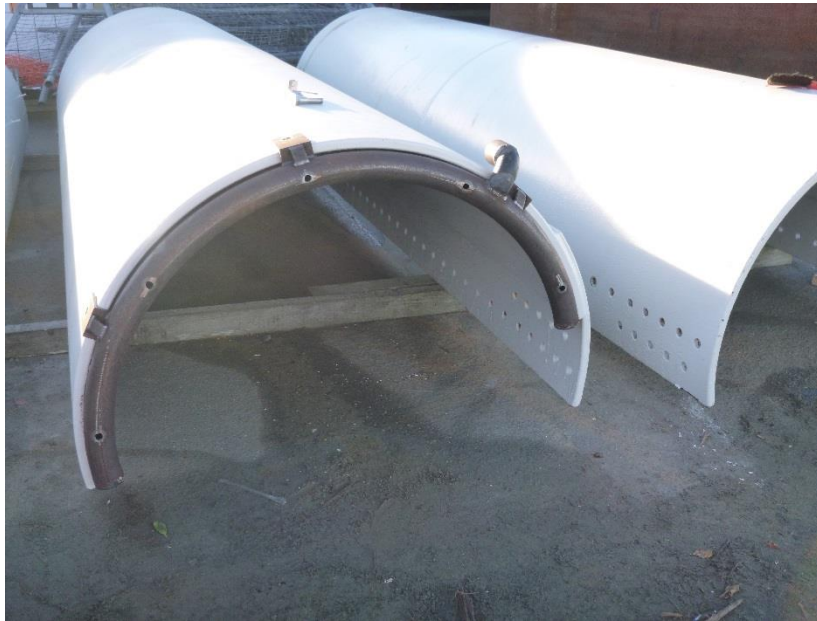
Methodology

EXCAVATOR DELIVERING PILE JACKET
1 : 100
