Safety in Design – Practice Forum

A forum for bringing stakeholders together to share, debate and develop consistency of practice for the health and safety of everyone we affect by our activities

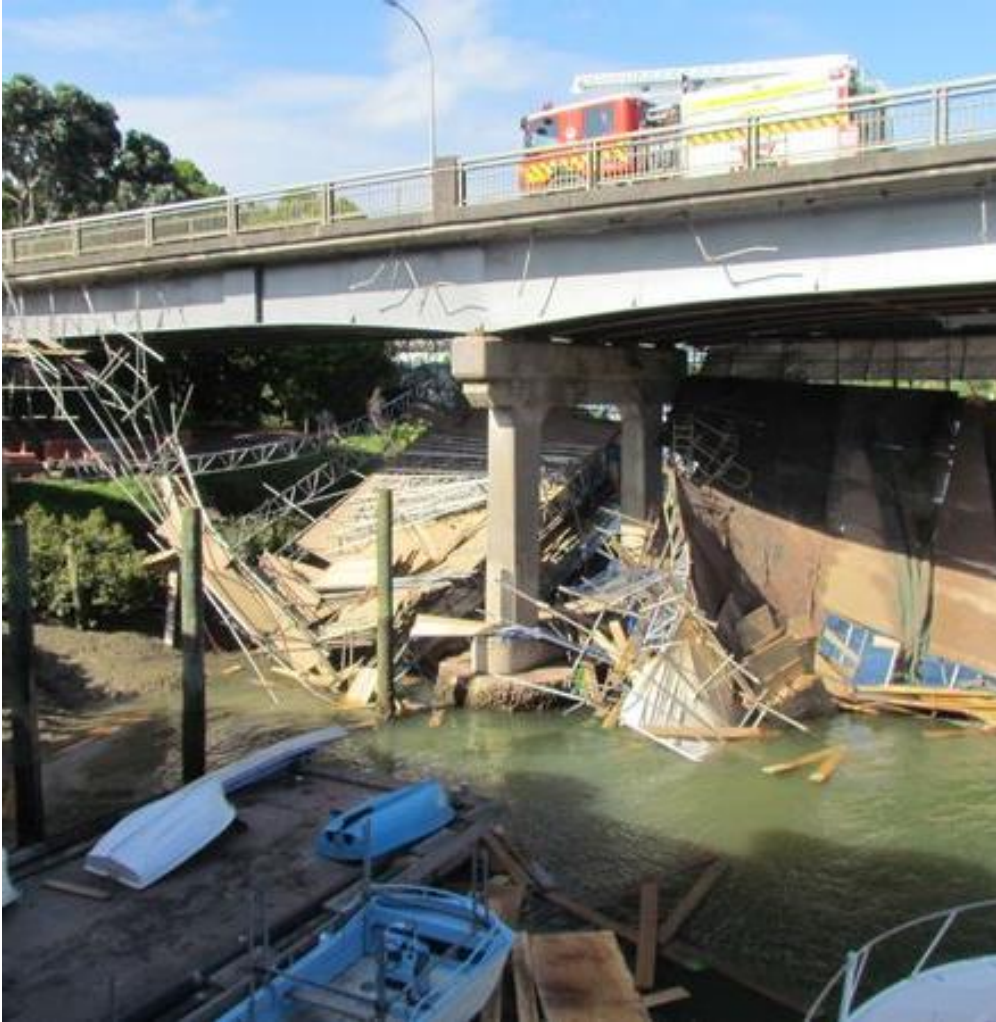
NZ Scaffolding highlights safe design

In 2017, the scaffold collapsed while seven workers were completing maintenance work on the bridge in Panmure. Six workers fell into the water and another was trapped on the scaffolding. No-one was seriously injured.

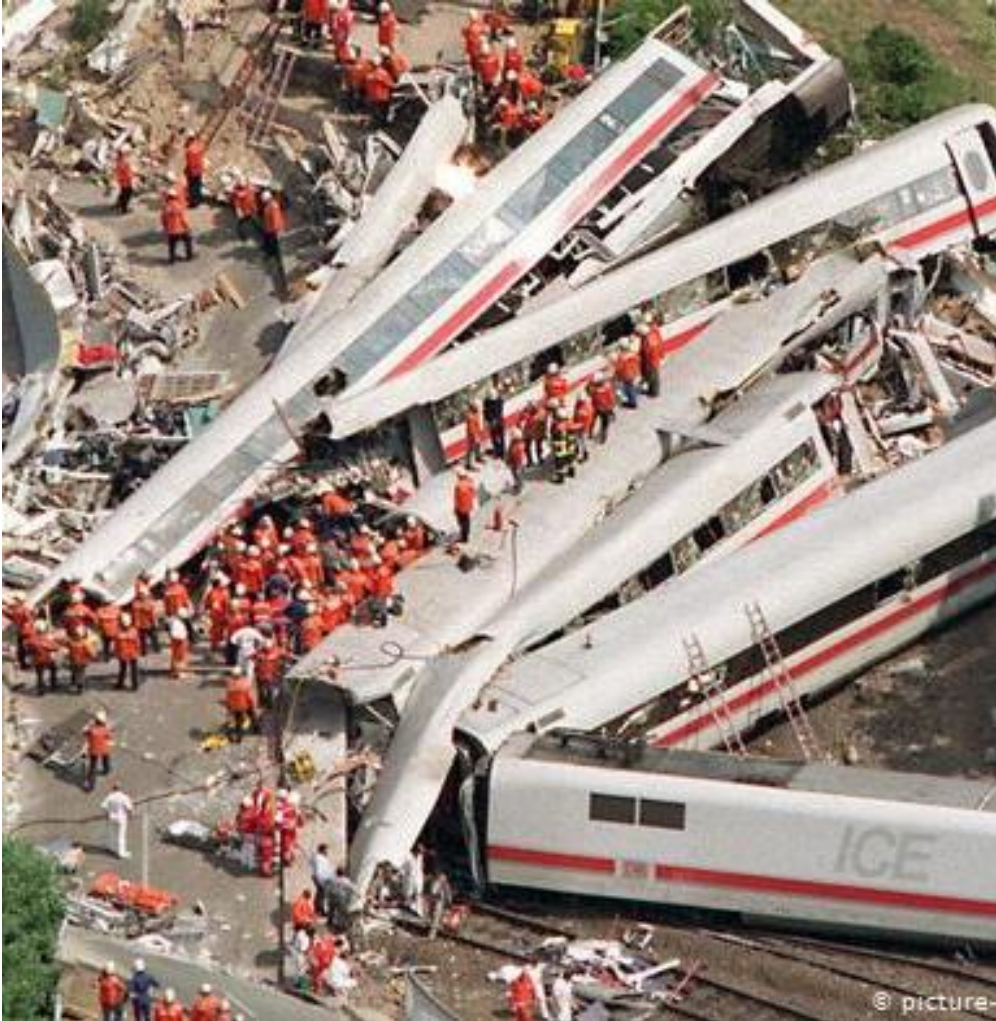
Eschede, Germany 1998 - 101 deaths and 88 injuries

Sophisticated wheel on the bogies was an elegant and rapidly implemented solution to a difficult problem.

The arrangement of the rubber cushion ring within the rim to the steel wheel (dual block wheel rather than the standard mono block wheel structure) made adequately inspection impossible once in service. Therefore, the integrity of the wheels could not be assured.

Failure to acknowledge the failure of a similar wheel design on a tram in Hanover the year prior.

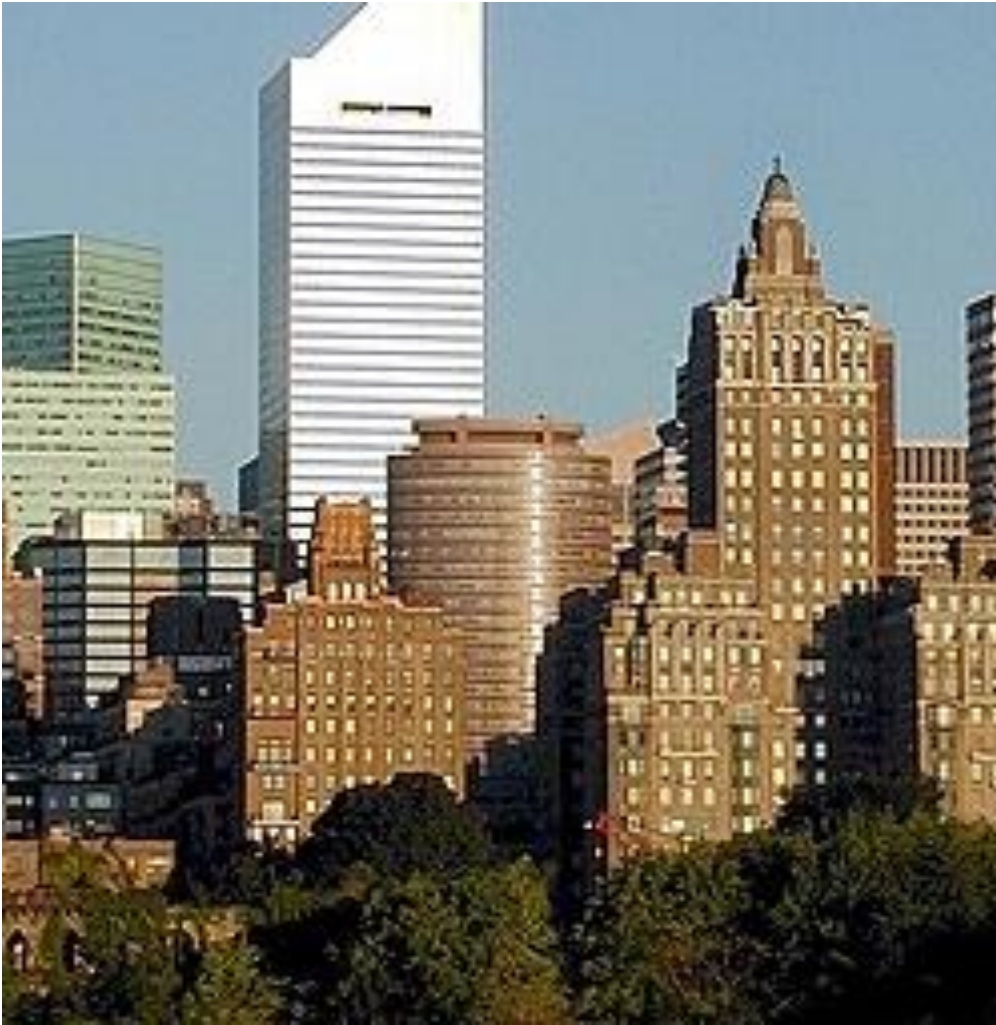
Citicorp, New York 1970s

The designer met code compliance for wind loads and in so doing missed the critical load case - high windlass on the corners and not the face of the building.

The 54 story Citicorp building had a 1:16 AEP (Annual exceedance Probability) of failing in high winds. In the period when strengthening works was being done there was one cyclone tracking towards New York and the building would have evacuated had the cyclone not changed course.
