Safety in Design – Practice Forum:

CRL/ Link Alliance – SID implementation and some Lessons Learnt

Andrew Richardson, Design Manager
24th August 2020

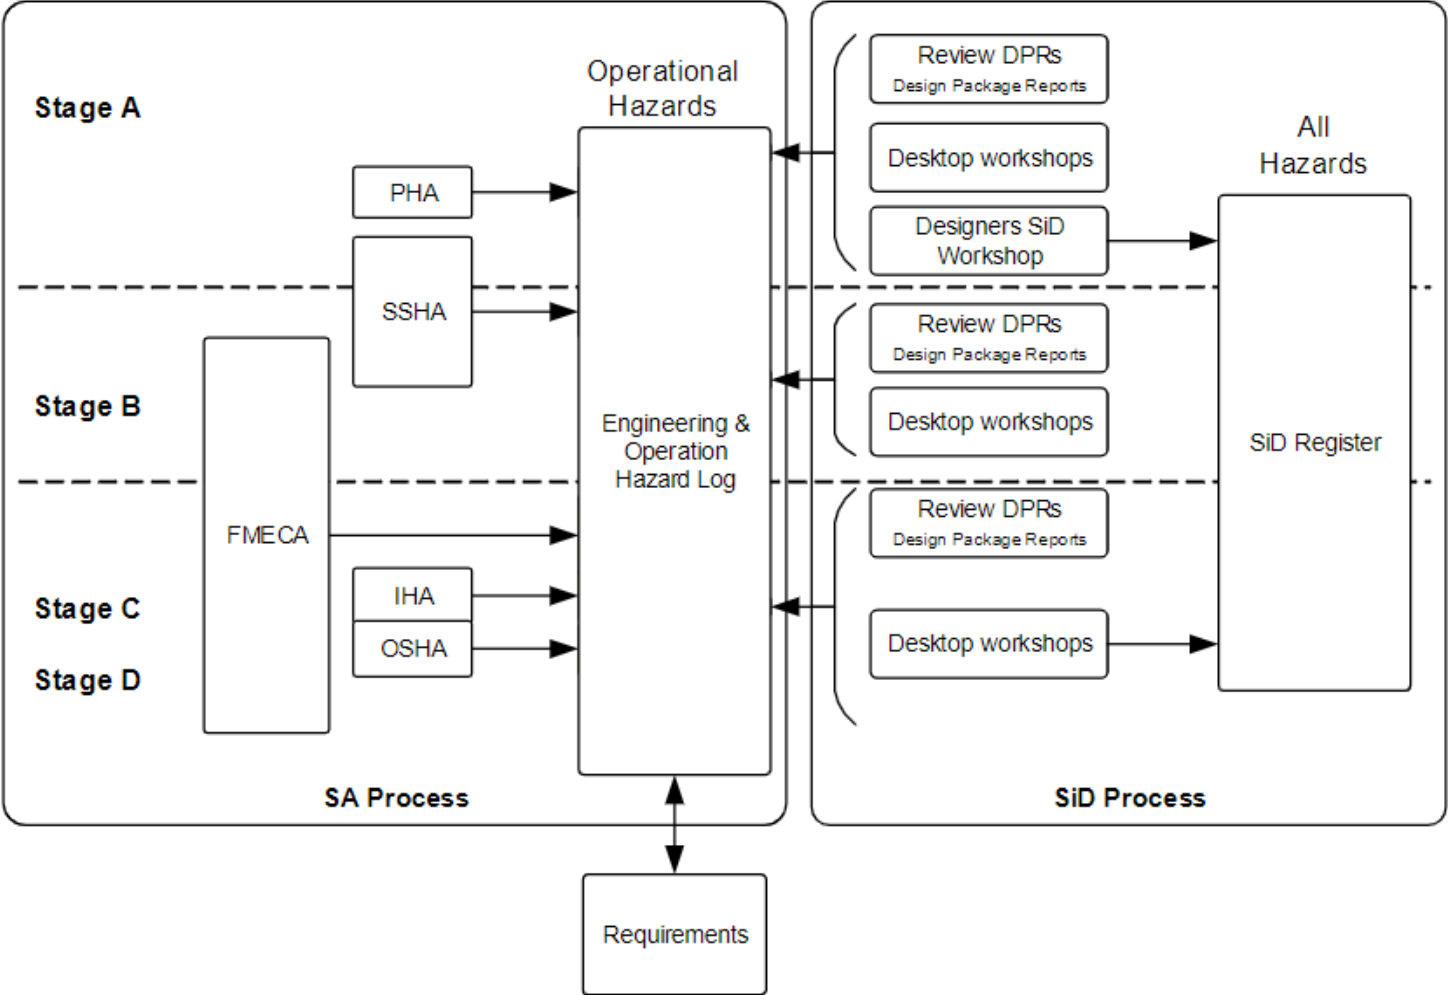
Figure 13 – Complementarity of SiD approach into E&O Hazard Log Management

Complementarity and demarcation between SiD approach and Operational Hazards management (as per EN50126, and detailed in chapter 8) is illustrated as per the following flowchart:
